## Hospital Steam Coil Issues

MSC was retained to evaluate and diagnose an issue on the steam heating coil of AHU-10 located in a lower level mechanical room. The steam coil was logging condensate and was not draining properly under normal operating conditions causing nearly half of the effective coil surface area to be unheated.

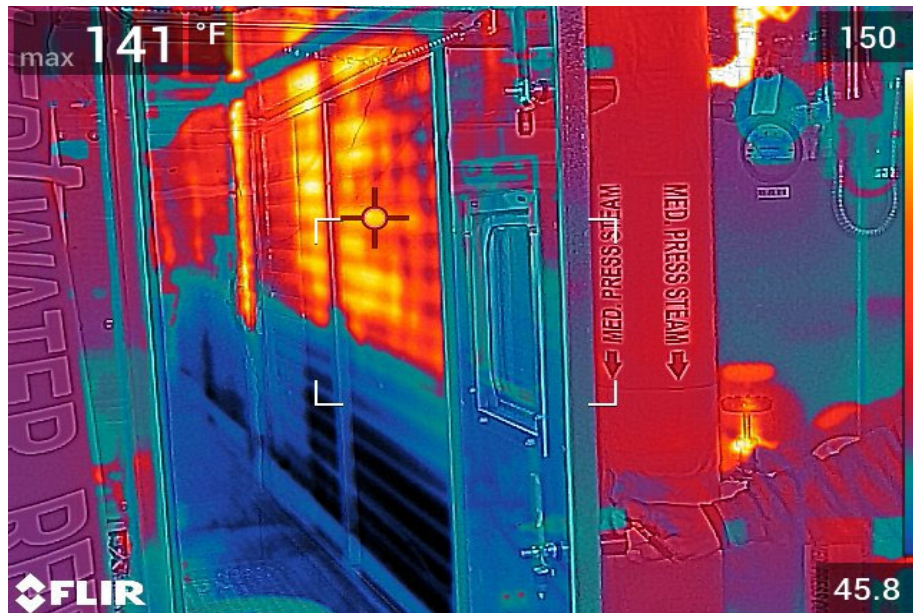
Figure 1: Heating Coil As Found

- Upon arriving at the unit, the logged condensate level was 24" from the bottom of the coil (Figure 1). The lower freeze stat was jumped out by others and the steam control valve was at 30-35%. The coil was operating around 3-4 PSI as observed on the installed pressure gauge.

Due to space and elevation issues, the current coil and trap are unable to overcome external pressure drops required to effectively remove the steam condensate by means of the APT-14 pump trap under most low load conditions. It is recommended that the coil and trap drain to a free vented collection point where it can be pumped into the condensate collector in the mechanical room. This could be done by a similar steam powered pump trap as is in the sump or by an electric powered condensate pump and reservoir.

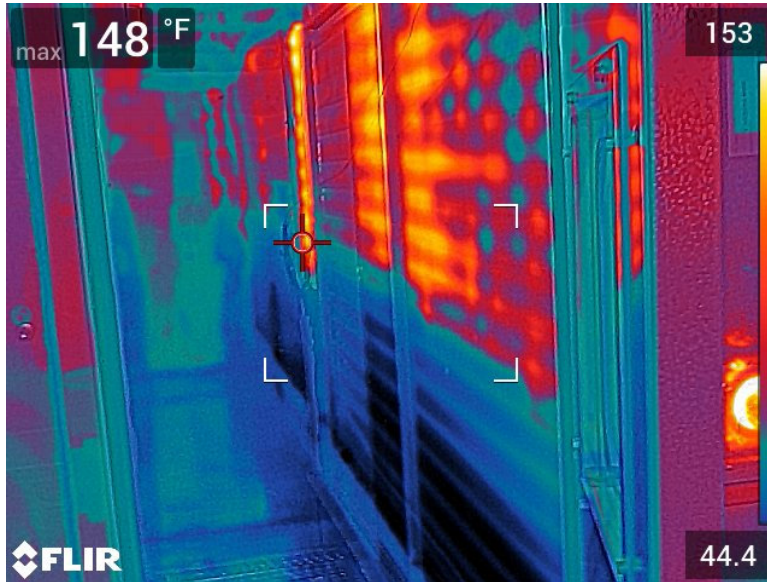
Figure 2: Centralized Heat Signatures

- The coil assembly has nearly a 1/4"-3/8" on 4' pitch towards the condensate drain.
- The steam coil is fed from both sides. At first glance it appears to be a no freeze coil with a 5/8" inner tube and a 1-1/8" outer tube with the steam supply being fed into the 5/8" from right to left, looking in direction of airflow. However the header on the left hand side also appears to feed the 1-1/8" tube. Due to inconsistent heat signatures in the center of the coil at part load (Figure 2) the coils circuiting was questioned.

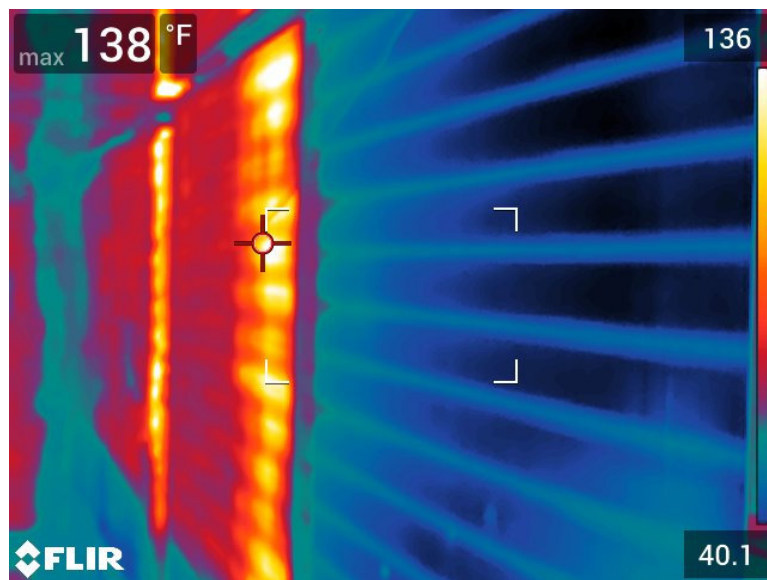
Figure 3: Left Header Blanked Off

- The supplies to each header were blanked off one at a time and the result was that each side feeds half of the coil from either side (L/R) with the middle of the coil being what appears to be the termination point for the interior dispersion tube (Figure 3).

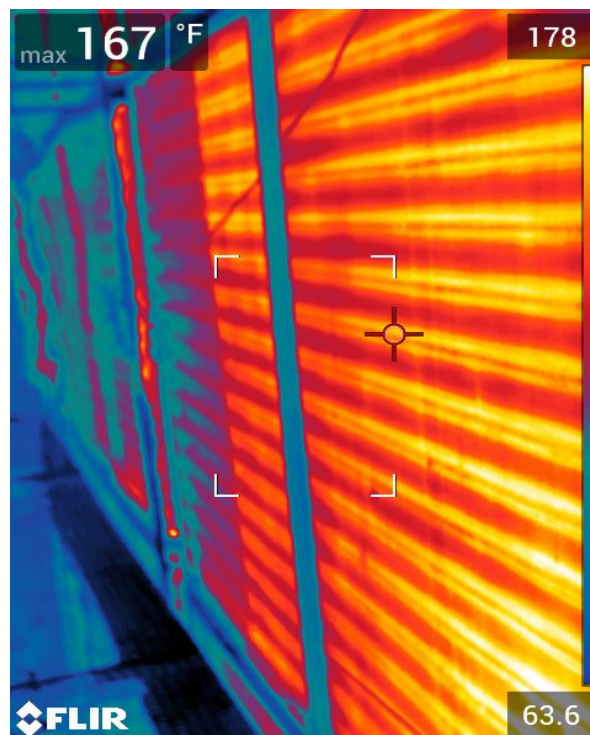
Figure 4: Coil At Full Heat

- While looking at the unit, the upper freeze stat tripped and caused the steam valve to open fully allowing 30 PSI steam to the coil. At this point, all logged condensate was pushed out and the pump trap began working (Figure 4).

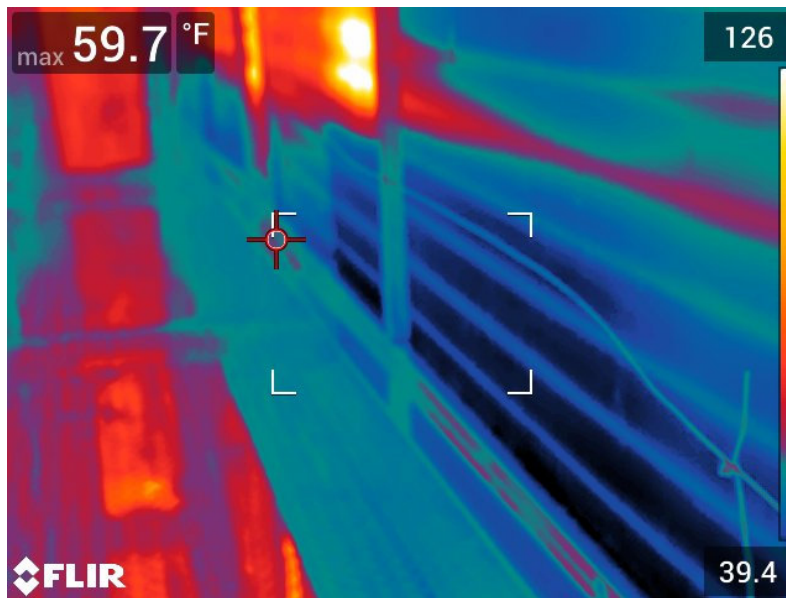
Figure 5: Lower Condensate Logging

- The pump trap remained in operation the rest of the time onsite and maintained an average of 150°F at the body. It was reported that this does happen when there is a sporadic operation of the pump trap.
- Two additional condensate return lines feed into the APT-14 pump trap and they are said to be condensate returns from the two dishwashers in the adjacent space. They were not traced out and confirmed at this time.
- Once the unit resumed normal operation with a valve position of 30-35%, there was a band of condensate at the bottom of the coil nearly 8" tall. The coil maintained a pressure of 3 PSI and the condensate level held during the observational period (approx. 2 hours) (Figure 5).

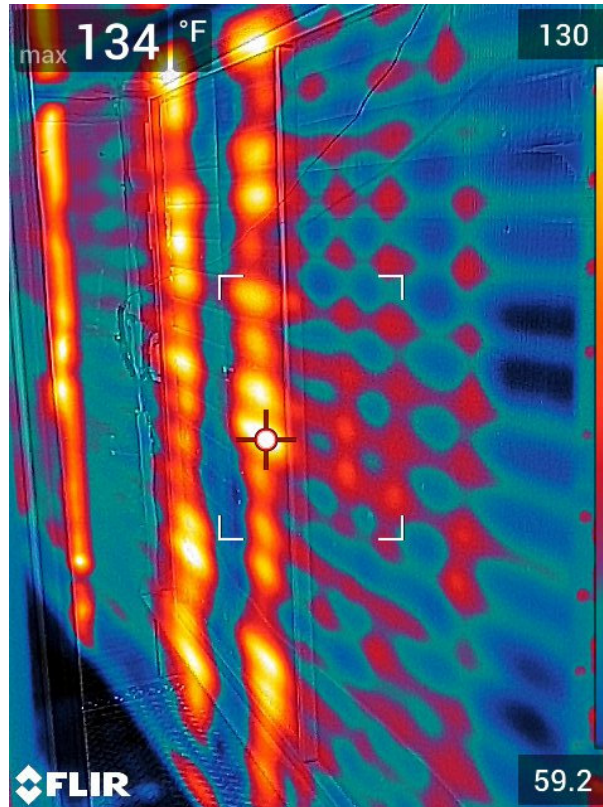
Figure 6: Trap Piping

garden hose set as a quench. The coil at this time has a uniform distribution of steam with no evidence of condensate in the coil (Figure 6). Figure 6 was taken with the steam valve at 30% open.

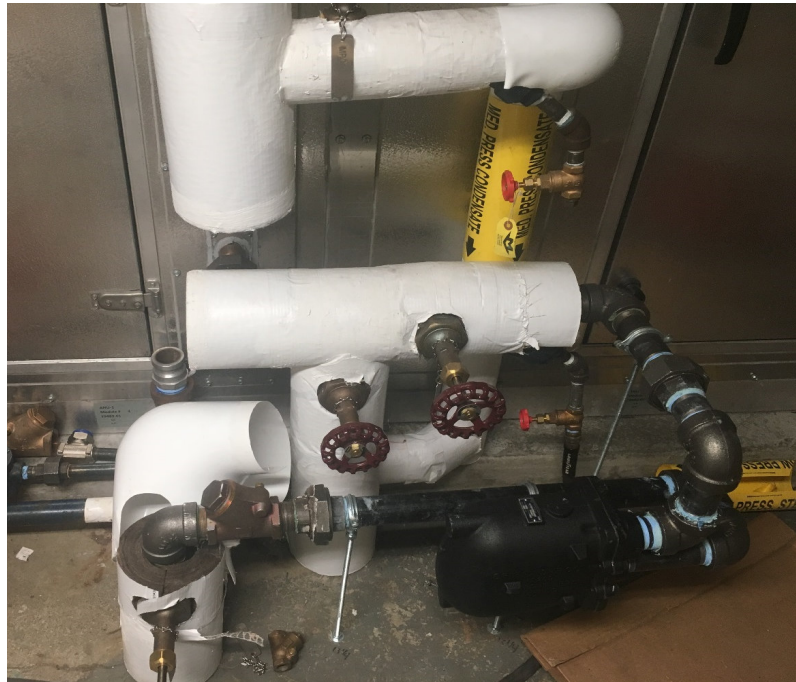
Figure 7: Trap Piping

- The outside air temperature as a control point is taken at the inlet to the steam heating coil and not indicative of the actual outdoor air temperature. A 0.4°F difference between the outdoor air temperature and the preheat leaving temperature was observed with the coil off. The preheat leaving temperature sensor is mounted to the discharge of the heating coil.
- The inlet to the Spirax-Sarco FTB-200 trap is mounted 7" below the outlet of the coil, the outlet of the trap is 9" above the floor (Figure 7).

There is approximately 24" x 24" of floor space at the base of the coil which would fit a Xylem M2DCC24 or a Shipco ACD/ACH style dual pump condensate reservoir and pump unit. As the outlet of the current trap is 9" off the floor, selection of the unit should take into consideration the height of the condensate inlet as well. With that being said, based on dimensions, a Shipco ACD/ACDH or comparable pump unit would be a preferred selection providing it is adequately sized. A cut sheet has been provided with this report. The pump would need to overcome a maximum rise of 8' and travel across the room approximately 20' before being connected to the atmospherically vented condensate return pump station in the mechanical room.
